Stamping Process Reduction of Waste from the Production Process for Plastic Parts

Somporn Phromduang*, Saisunee Pongpatanasuegsa, and Phakphong Kaennarong

The Industrial Engineering field, College of Engineering, Rangsit University, Pathum Thani, Thailand
Corresponding author, E-mail: Somporn.p@rsu.ac.th

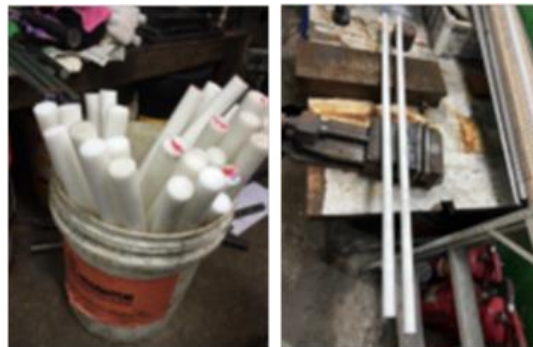
Regarding the material preparation, the plastic part molding process begins with the preparation of the materials used to make each part of the workpiece in order to prepare the work before moving on to the next step, as shown in Figure 3 and 4.

Figure 3 and 4 POM materials (polyoxymethylene)

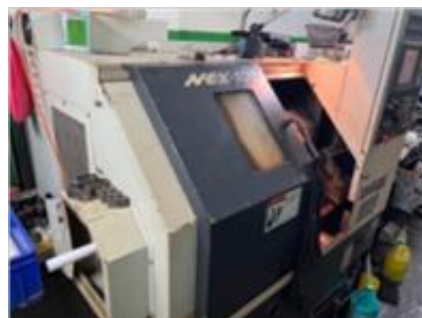
The assembly of the materials with the fixtures is the process of bringing the materials from the material preparation to the turning and milling process. The lathe will hold the workpieces and mill them. The lathe used in the manufacturing process is a CNC lathe as shown in Figure 5.

Figure 5 CNC Lathe

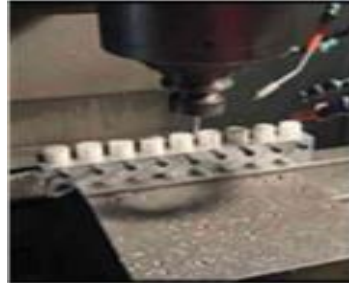
The prepared materials are assembled with the fixture for use in the next step, as shown in Figure 6.

Figure 6 Assembling the prepared materials with the fixture (CNC lathe)

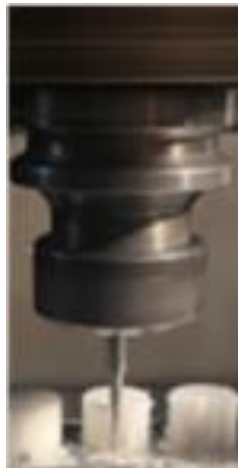
Machining according to the design involves the use of CNC machines to mill the workpieces to the form of the plastic part, as shown in Figure 7.

Figure 7 Drilling machine

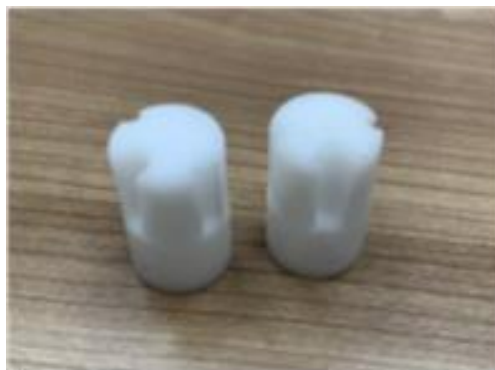
After the turning according to the model, the workpieces must be inspected for smoothness and to obtain the dimensions according to the plastic part model, as shown in Figure 8.

Figure 8 Finished machined workpieces ready for assembly

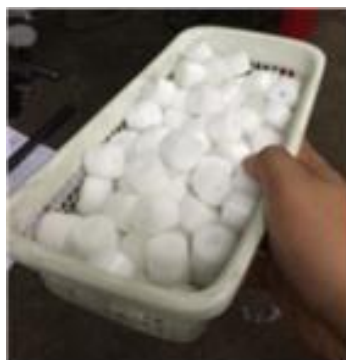
After checking the correctness and obtaining the size according to the plastic part model, the inspected pieces will be stored as shown in Figure 9.

Figure 9 Collection of the pieces for use in the next step.

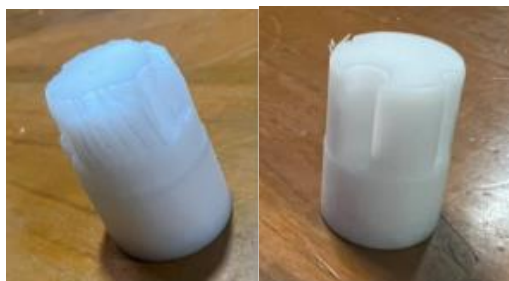
The cause of the problems shown by the cause-and-effect diagram can demonstrate that the problem that causes the most waste is the machine not holding the workpieces tightly, which results in the workpieces being damaged by scratches, as shown in Figure 11.

Figure 11 Damaged workpieces

The problem of the damaged workpieces was found to be caused by rotation because the fixture did not hold the workpieces tightly, resulting in imperfect production and a large amount of waste. Therefore, a new fixture was designed and created using low carbon steel (SS45) to solve this problem and increase the number of undamaged plastic workpieces, as shown in Figure 12.

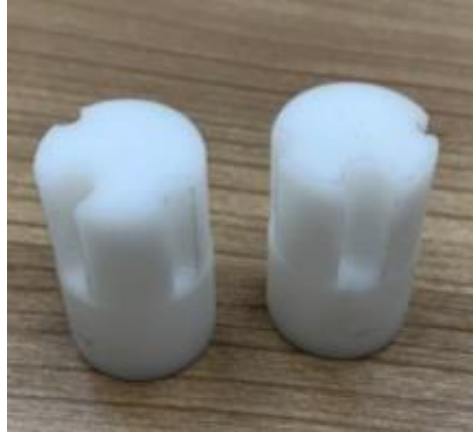
Figure 12 Undamaged plastic parts

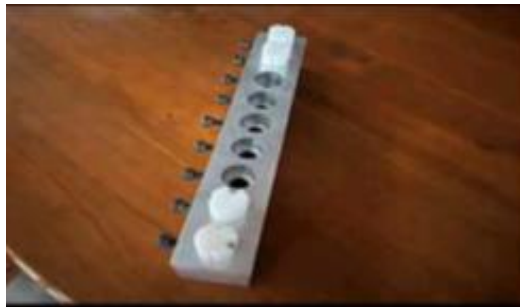
From the usage, it was found that the original fixture was only useful for holding the workpieces, which was only one advantage and very minor when compared to the disadvantages, such as scratching the workpieces and not holding them tightly. The main reason for damaging the workpieces was that the original fixture required a screw to lock the workpieces into place, as shown in Figure 13.

Figure 13 Example of the original fixture

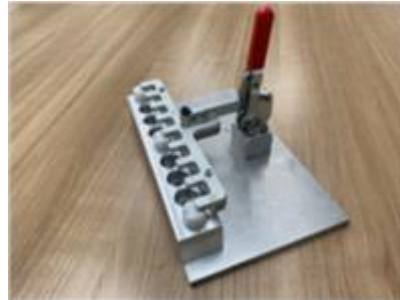
problems. The new fixture is designed with the workpiece holder on top in order to grip the workpieces more tightly, thereby reducing the scratches on the workpieces and making it more convenient to remove and install the workpieces, as shown in Figure 16.

Figure 16 New Fixture

Improvement guidelines: Since the production of plastic parts of the original fixture had problems with the workpieces not being held tightly, which caused damage to them, the researchers designed and built a new fixture based on the design-build principle (Meesang, 2023), using low carbon steel (SS45) as the material, which may have higher production costs than the original fixture but can reduce production

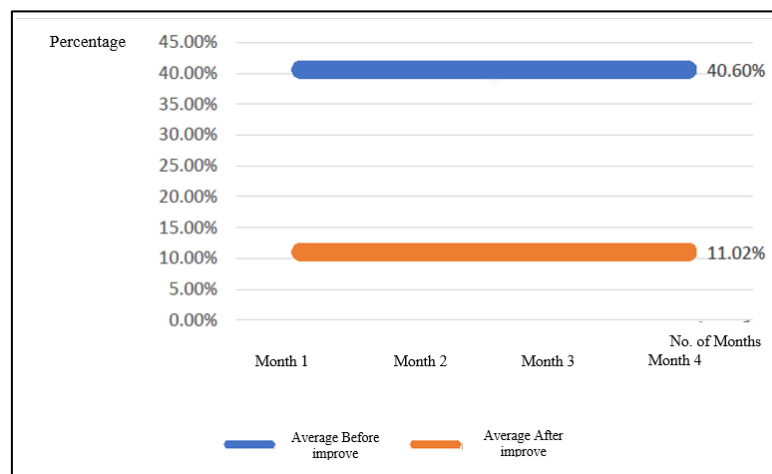
Based on Tables 4 and 5, the data can be presented as a graph showing the comparison of the average percentage of waste before and after improvement, as shown in Figure 18.

Figure 18 Averages before and after improvement

From Table 4 and 5 and Figures 17 and 18, it can be seen that before the improvement, the average waste was 40.60% of the total production. After designing and implementing a new fixture, it was found that the average waste was 11.02% of the total production (Besterlife, 2022). This means that the percentage of waste could be reduced by 29.58% or the total number of waste pieces could be reduced by 62,112 pieces. Moreover, the cost per piece is approximately 60 baht, totaling approximately 3,726,720 baht.
